POSTIRRADIATION EXAMINATION OF THE
PM-3A TYPE 1 SERIAL 2 CORE
PART I. POSTIRRADIATION EXAMINATION
OF FUEL TUBES

February 28, 1967

John B. Brown, Victor W. Storhok, and John E. Gates

BATTELLE MEMORIAL INSTITUTE
Columbus Laboratories
505 King Avenue
Columbus, Ohio 43201

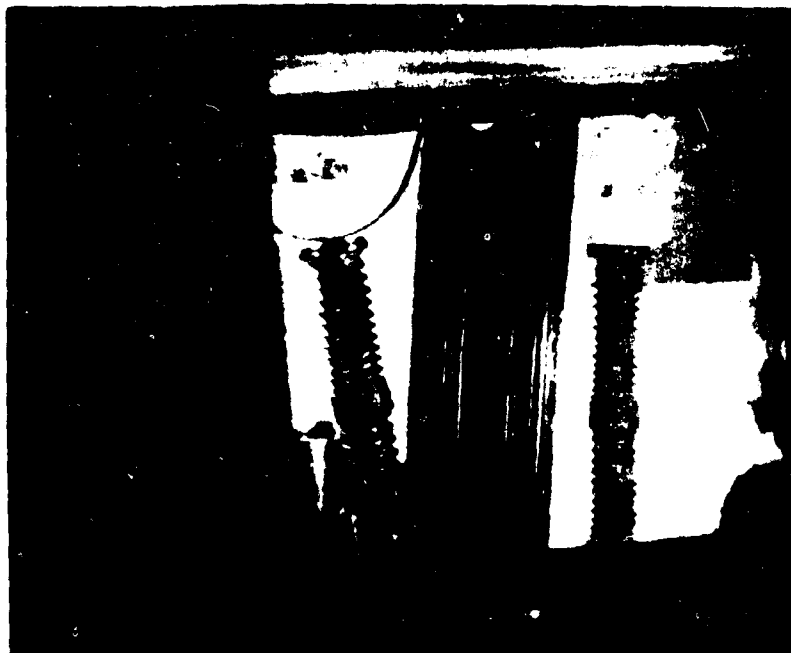
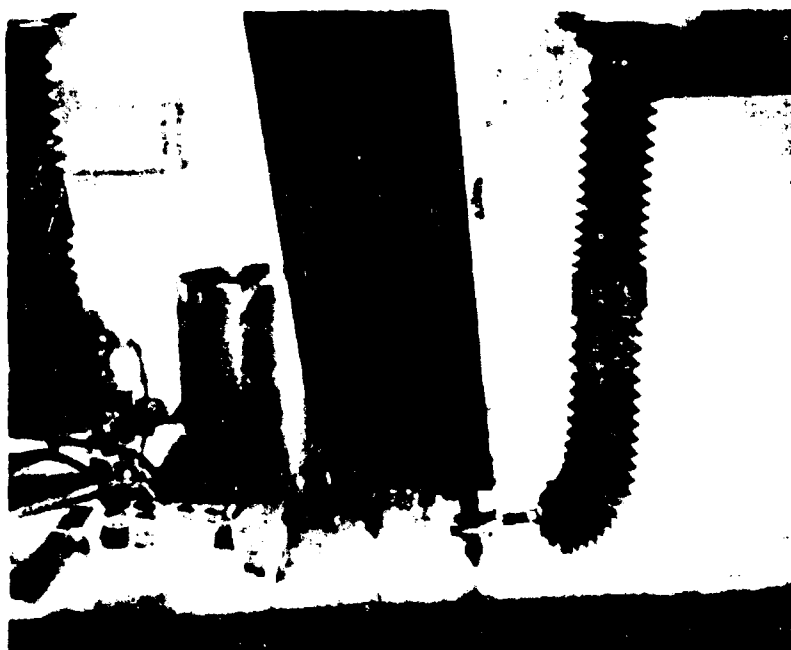
Figure 4 shows peripheral bundle 9 after being lifted from the transfer cask within the beta-gamma cell. Figure 5 shows the control rod exit end of the peripheral bundle 9. Several of the cadmium rods, placed in the core as an added precaution against criticality, are visible in Figure 5. Figure 6 shows end views (less control rod) of peripheral bundle 12. As shown in the above photographs, all core bundle exterior surfaces were coated with a black scale. Passage of light through the tubes provided evidence that the scale buildup did not block any of the coolant flow

FIGURE 4. PERIPHERAL BUNDLE AS IT APPEARED THROUGH THE HOT-CELL WINDOW

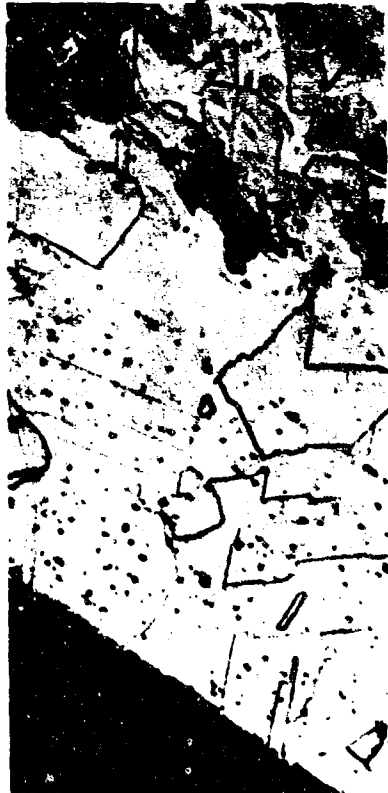
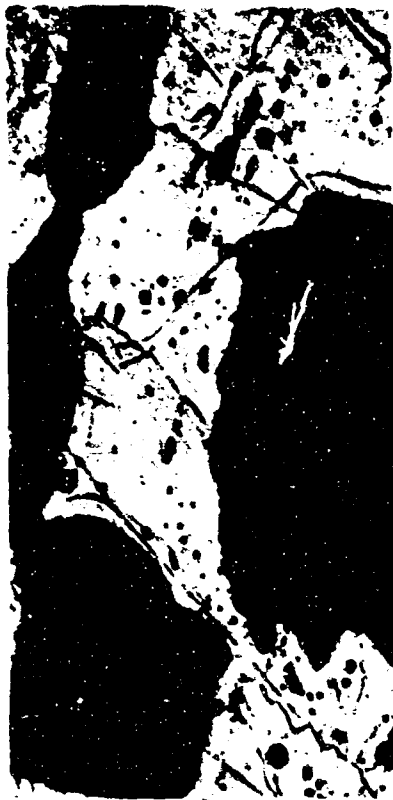
1. Position B: No cracks were found in the clad at this position on fuel element 12-46. Figure 14B-1 shows a typical micrograph of the clad and clad-fuel matrix interface. No damage was noted to clad or clad-fuel interface. Depending on size and orientation of grains, between 3 to 6 grains spanned the cladding thickness. Figure 14B-2 shows a typical micrograph of a UO_2 particle. Some porosity was observed in the UO_2 particles at this location.

2. Positions D and E: Figures 14D-1 and 14E-1 show typical micrographs of the cladding and clad-meat interface at the D and E positions of fuel element 12-46. Discussions of D and E positions are combined because of similar results. The following comments apply to both positions on the fuel element:

FIGURE 14. MICROSTRUCTURES OBSERVED AT SEVERAL POSITIONS IN FUEL TUBE 12-46

- a. About 30 cracks were detected around the periphery of the outer clad.
- b. Many cracks (about 1/3) were double at the outer edge and combined into a single crack at some point within the clad and continued as a single crack which terminated at a fuel particle.

- c. All cracks detected were intergranular.
- d. The cracks appeared to have been initiated at the outside edge of the outer clad since some smaller cracks were started at the outside edge of the clad but terminated before completely penetrating the clad.

- e. No cracks on the inner clad were observed.
- f. All cracks that penetrated the clad appeared to terminate at a UO_2 particle close to the clad-fuel interface.

- g. Grain boundaries appeared to be relatively free of precipitates, indicating that the stainless steel was not sensitized.
- h. In some cases, foreign material appeared in the cracks.

3. Position F: Figure 14F shows a typical micrograph of the clad and fuel matrix at the F position of fuel element 12-46. No crack in the cladding was found to penetrate completely through the clad at this position. The micrograph shown represents the worst clad condition found in this position.
4. Positions G and H: Figures 14G and 14H show typical micrographs of the cladding and fuel matrix at the G and H positions of fuel element 12-46. No cracks or other damage was noted to the cladding or clad-meat interface at this position. Note the absence of spherical porosity in the UO_2 particles.

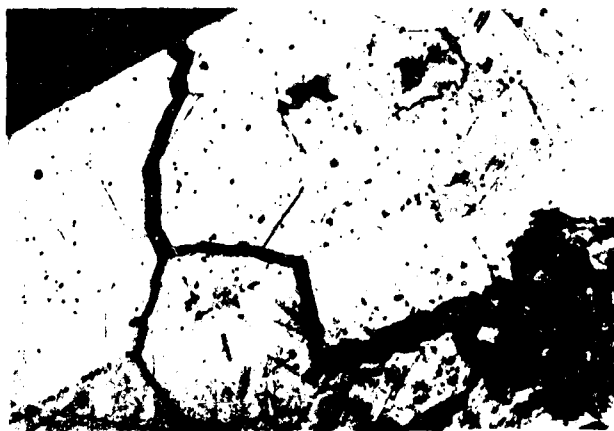
1. Branch-type cracking observed in the fuel tubes is indicative of stress-activated chemical attack, rather than purely mechanical cracking. One example of branch-type cracking is shown in Figure 15a.

a. Etched

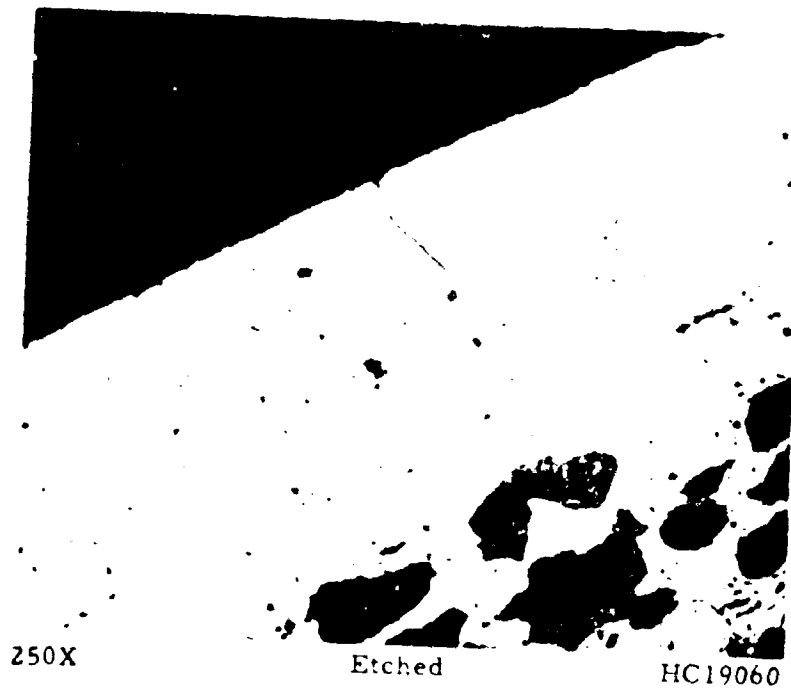
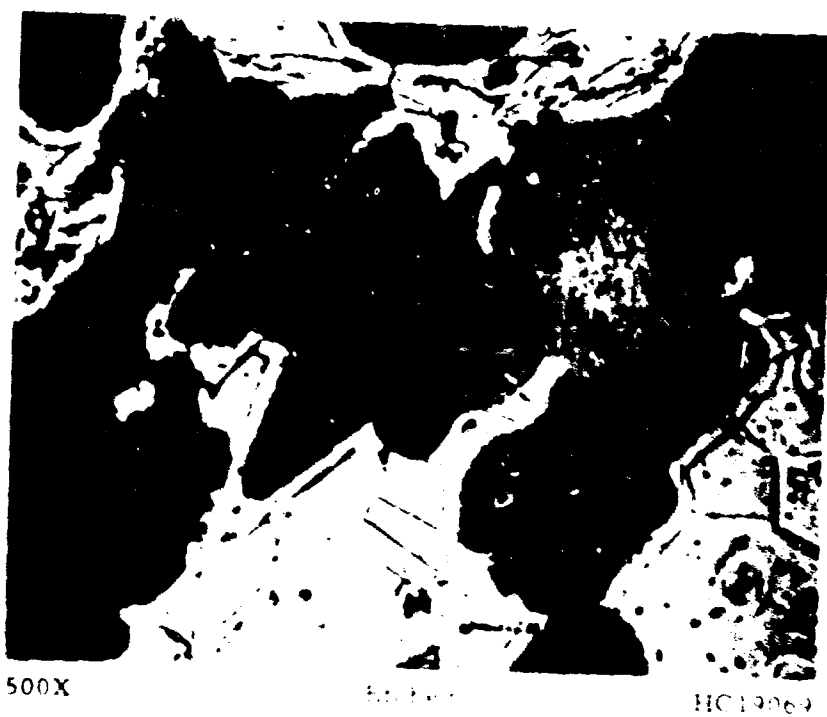
Figures 18a and 18b represent typical microstructures of fuel tube 12-90. Figure 18a shows a crack which extends into the outer clad approximately three mils. This was the only crack found on this specimen which was taken from the high performance region of fuel tube 12-90. Figure 18b shows the condition of the dispersion fuel in the vicinity of a UO_2 particle. An indication of second phase material was also observed in the UO_2 particle. Identification of the second phase was not attempted, since it seemed unlikely that the material contributed to clad failure. The 6-micron-thick band around the fuel particle probably reflects the fission product recoil range, rather than interaction between UO_2 and stainless steel.

a. Clad, High-Performance Metal Specimen 12-90-E

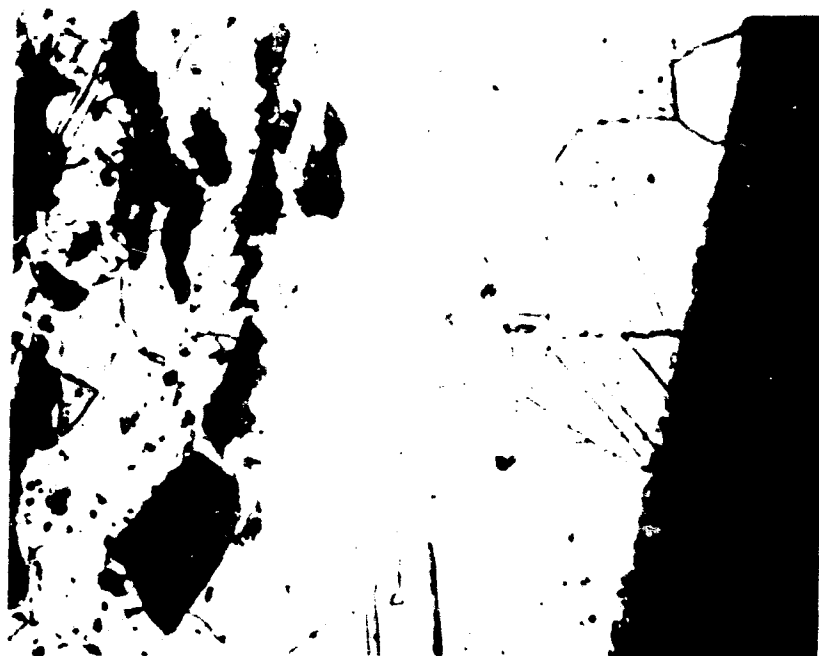
Figures 19a and 19b show micrographs of a transverse specimen taken from a low performance region of fuel tube 12-90. No cracks or crack indications were found in the clad at this position on fuel tube 12-90. Also apparent is the lack of spherical porosity in the UO_2 . A recoil region was visible in the stainless steel matrix around the periphery of the UO_2 particles, Figure 19b.

a. Typical Grain Microstructure - Low-Performance Region (Inner Port Area) - Tube 12-90

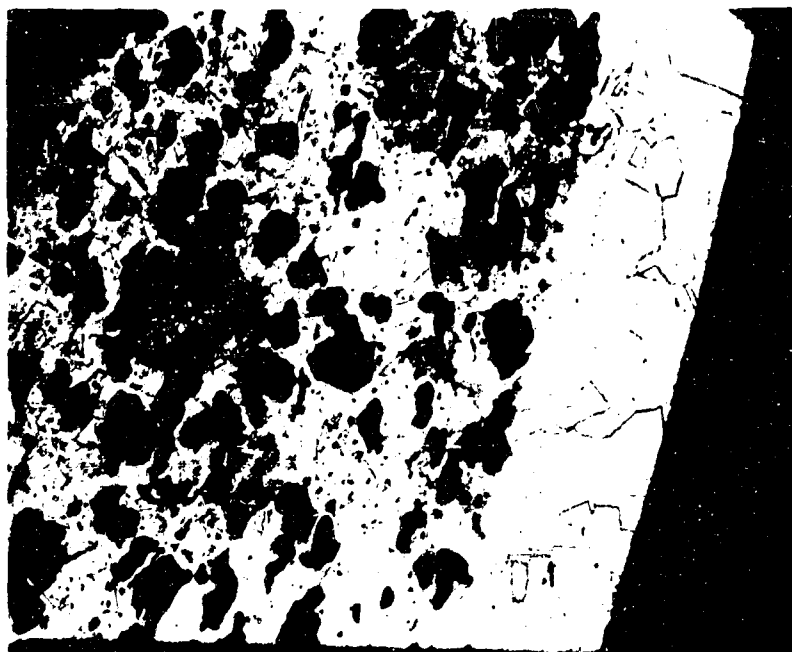
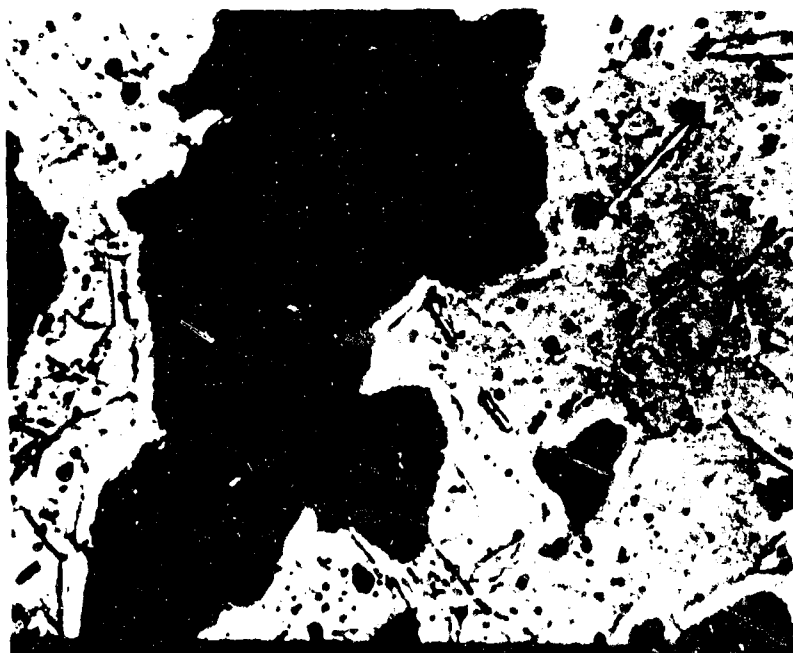
Figures 20a and 20b are micrographs of a transverse specimen taken from fuel tube 12-102 at the E position. Figure 20a shows the clad condition at this position. No cracks or crack indications were found in the clad at this average performance position on fuel tube 12-102. Relatively large quantities of fission gas bubbles were present in the UO_2 particles in this region, Figure 20b.

FIGURE 20. TYPICAL MICROGRAPHS FOR SPECIMEN 12-102-E

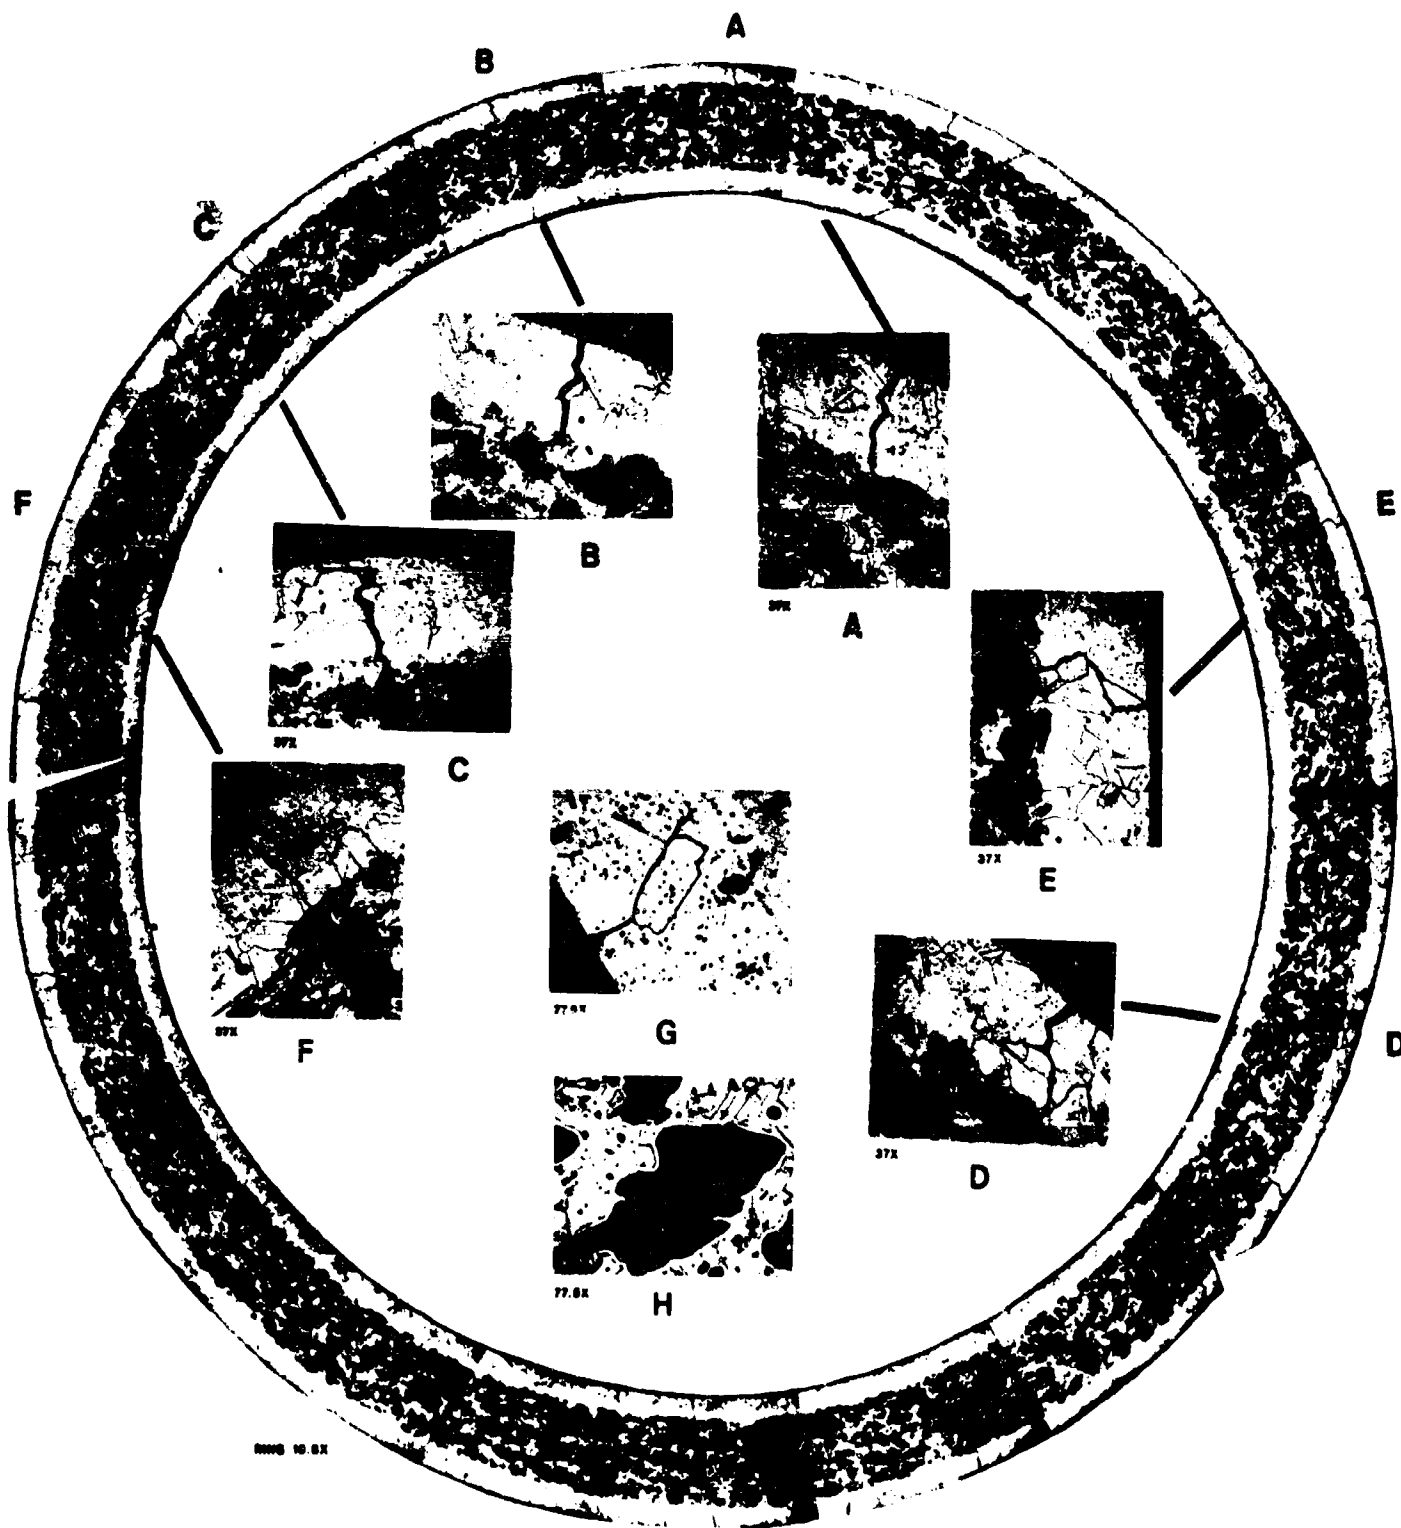
Figures 21 and 22 show results of metallography on two fuel tubes taken from the center bundle. These fuel tubes were located in positions of equal symmetry within the center bundle. Both transverse specimens were cut from the high performance region of both fuel tubes. Figure 21 is composed of a photomicrograph composite of specimen C-1-E with higher magnification micrograph inserts depicting selected clad cracks. Note that there appears to be no preferred pattern as formed by the clad crack positions located within the outer clad. Again, cracks were intergranular in nature, and limited to the outer clad tube. Figure 22 shows selected micrographs depicting microstructure of the specimen taken from the high performance domain of fuel tube C-2, i.e., specimen C-2-E. Figure 22a, and -b are micrographs of the same clad crack. Note that the crack is intergranular and terminates at the surface of a UO_2 particle resulting in an open path between cooling water and fission products. Figure 22c and -d illustrate two more examples of intergranular cracking terminating on the surface of a UO_2 particle. Apparently the void in the stainless steel matrix caused

FIGURE 21. MICROGRAPH COMPOSITE OF FUEL-TUBE SPECIMEN C-1-E WITH HIGHER MAGNIFICATION INSERTS

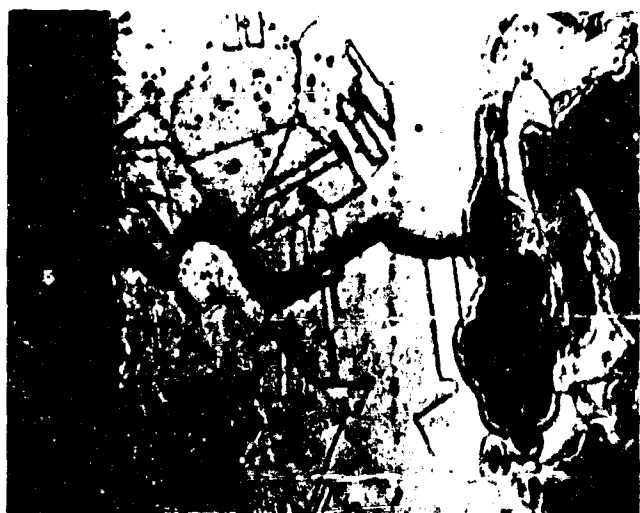
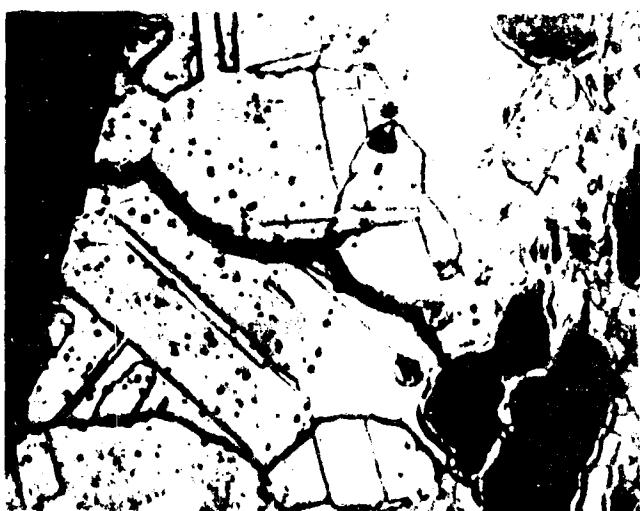
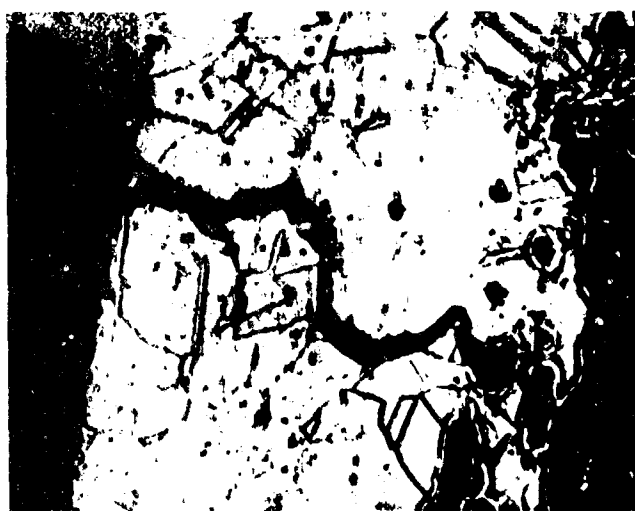
FIGURE 22. SELECTED MICROSTRUCTURES OF SPECIMEN C-2-E

by the presence of a UO_2 particle acts as a crack arrester. The stress concentration at the crack notch is reduced significantly when the crack notch reaches the surface of a UO_2 particle.

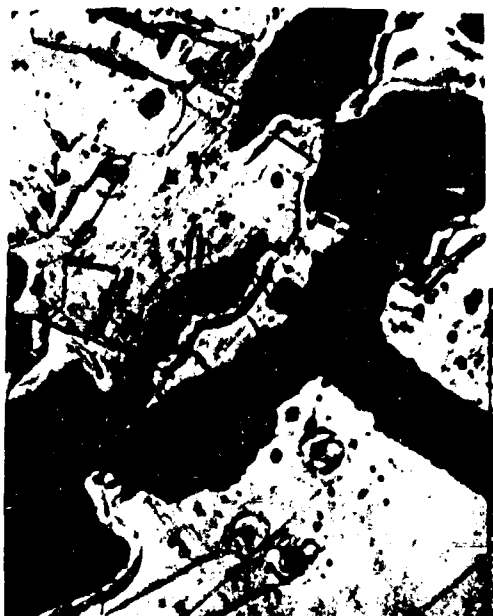
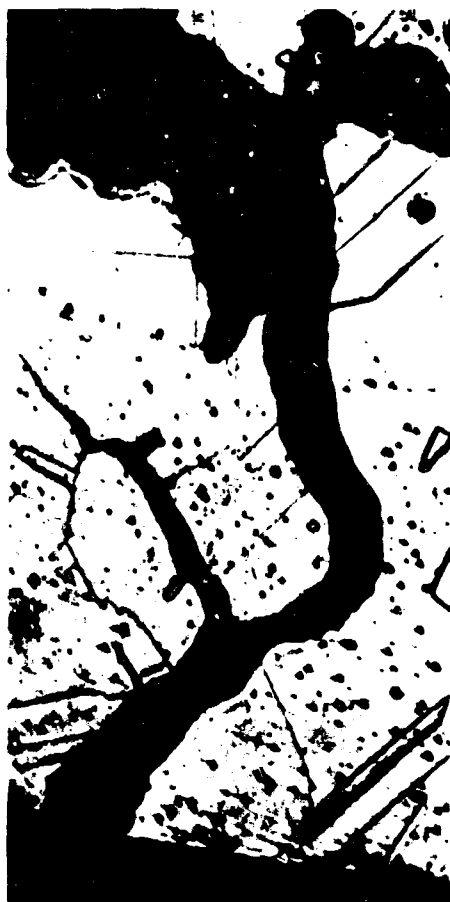
Figure 23 shows two photomicrograph composites depicting two of the many outer clad tube cracks detected in specimen C-2-E. Of special interest here is the fact that some unidentified material appeared to be lodged within the clad cracks, Figure 23a and -b. It appears that the foreign material lodged within the crack was one or both of the following:

1. UO_2 that had extruded, or in some other manner been transported, into the crack, or
2. Products of stainless steel corrosion.

In an attempt to identify the material present in the clad cracks, autoradiographs were taken of metallographic specimen C-2-E to detect the presence of uranium alpha activity in the crack. No evidence of uranium alpha activity in the cracks was detected. The results suggest that the material was not alpha active and hence, is probably a stainless steel corrosion product that formed when the crack surface was exposed to reactor coolant. Furthermore, Figure 23b shows that the foreign material was lodged within a smaller branch crack, the direction of which probably was not susceptible to an influx of material moving out through the trunk crack.

FIGURE 23. PHOTOMICROGRAPH COMPOSITE SHOWING TWO OF THE CLAD-TUBE CRACKS IN SPECIMEN C-2-E

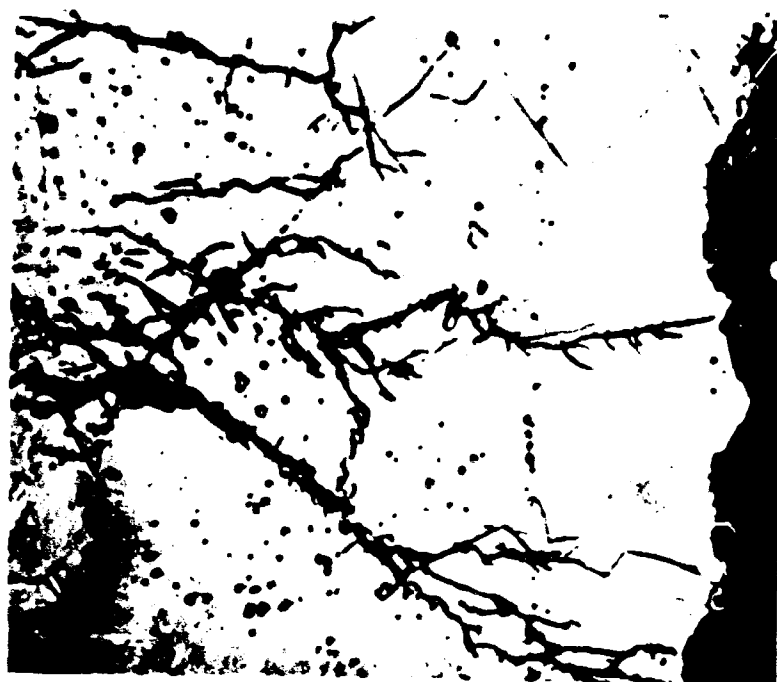
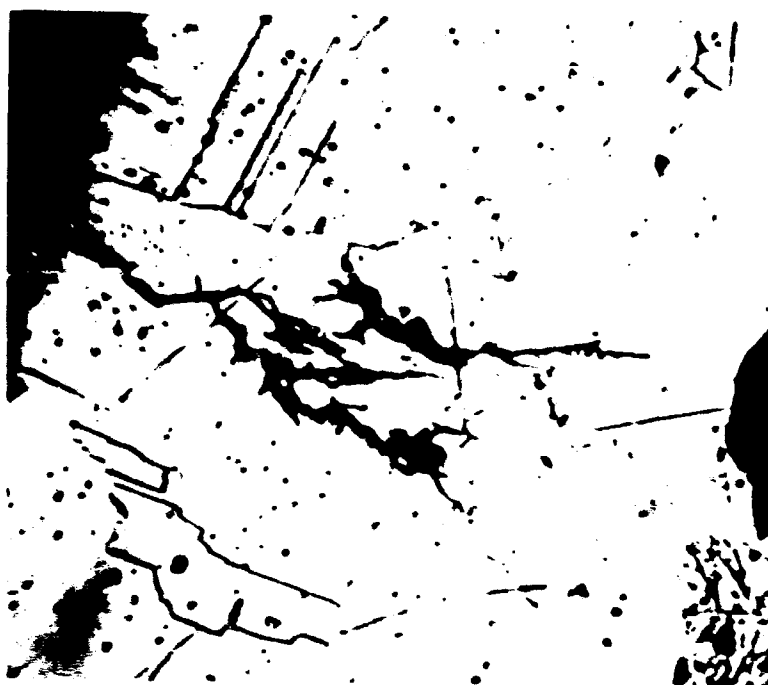
Chloride-Treated Fuel Tube. The cladding of chloride-treated fuel tube 12-139 which was removed from a low-performance region of the core was metallographically examined for cracks. No visual evidence of cracking was observed on fuel tube 12-139 prior to treatment. As shown in Figure 24, transgranular cracks typical of chloride-induced stress-corrosion cracking⁽¹⁰⁾ were found only in the outer cladding. The
